RESPONSE ACTION SUMMARY, SUBSURFACE INVESTIGATION, AND FUTURE PROPOSED ACTIONS

Olympic Oil
5000 W. 41st Street
Cicero, Illinois
Cook County

April 16, 2015

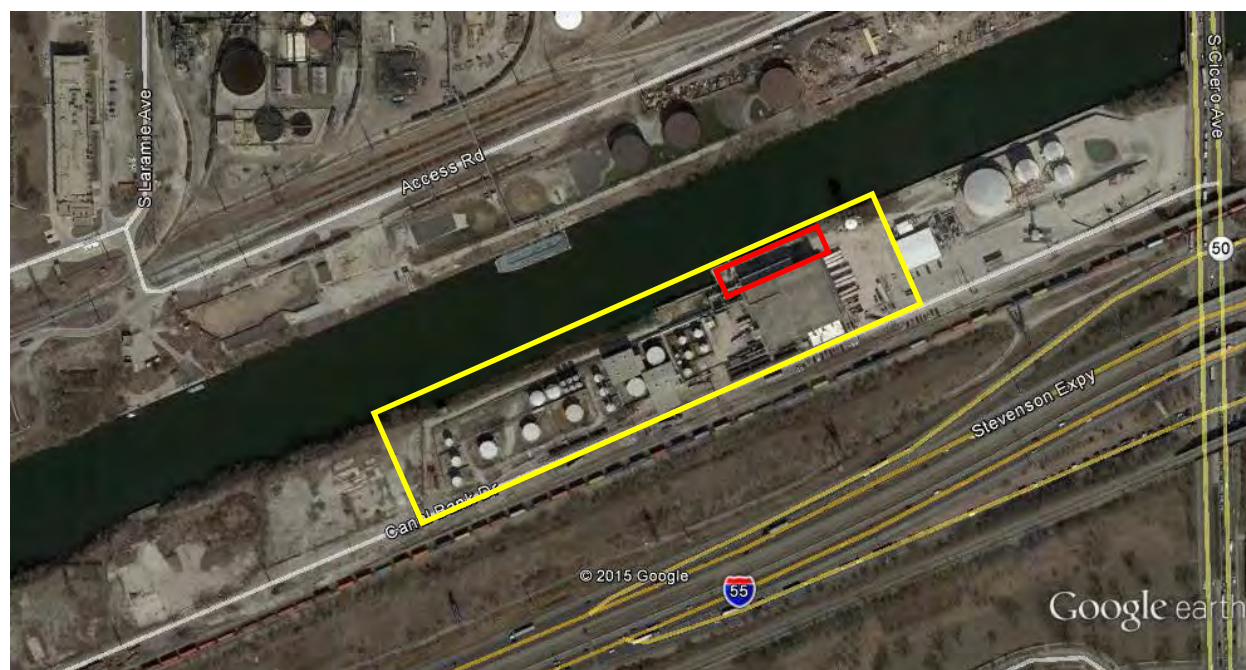
Figure 2 – Site and Surrounding Area (Google Earth 2013)

The Subject Property was located in an industrial area. Specifically, the Subject Property was bounded on the **north** by the Chicago Sanitary and Ship Canal; on the **east** by Asphalt Materials, Inc.; on the **west** by vacant land followed by Tough Cuts Concrete Services, Inc. – a concrete crusher; and on the **south** by 41st Street, followed by the Burlington Northern & Santa Fe railroad right-of-way and then Interstate 55 (Figure 2). The spill containment area (Site) is highlighted in red below, with Subject Property boundaries indicated in yellow.
